MTL TR 90-30

# METALLURGICAL ANALYSIS OF LEAKING TRAY PACKS

U.S. ARMY MATERIALS TECHNOLOGY LABORATORY  
METALS RESEARCH BRANCH

May 1990

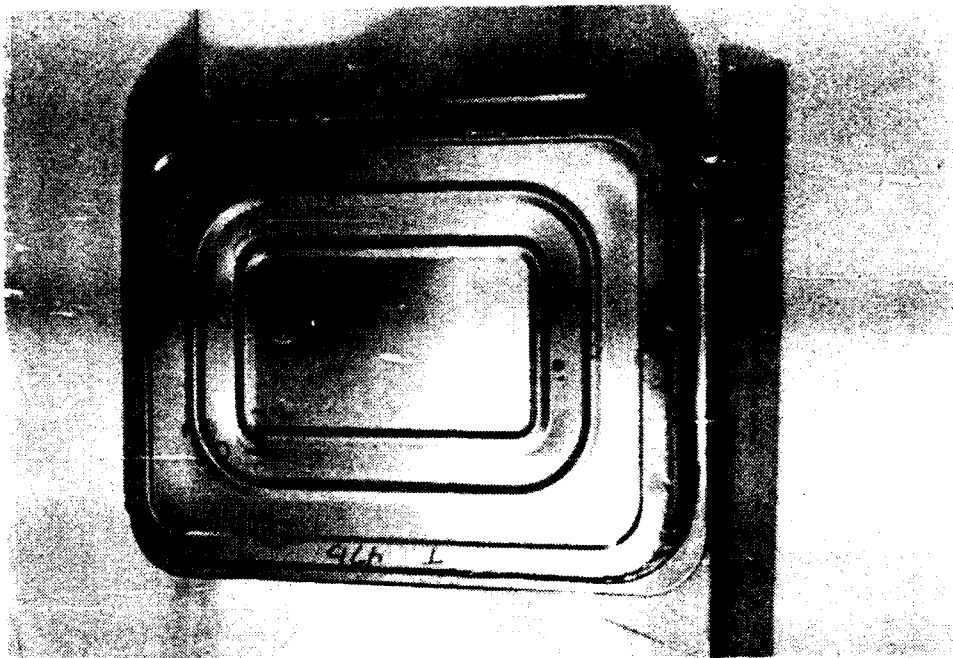
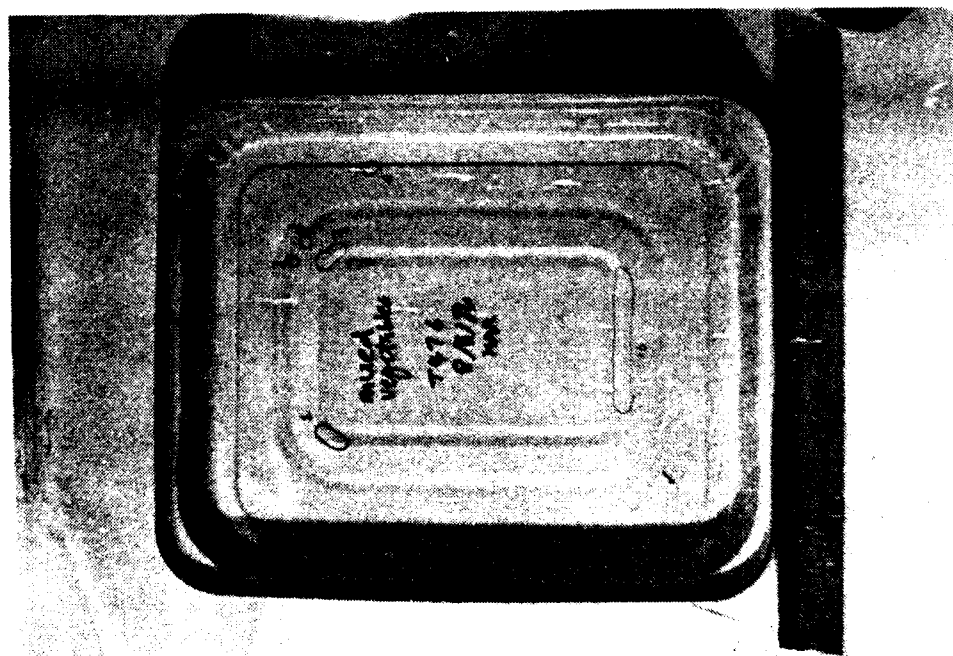
Figure 2. Circled 'gray spots' on the exterior and interior of used tray (T476).

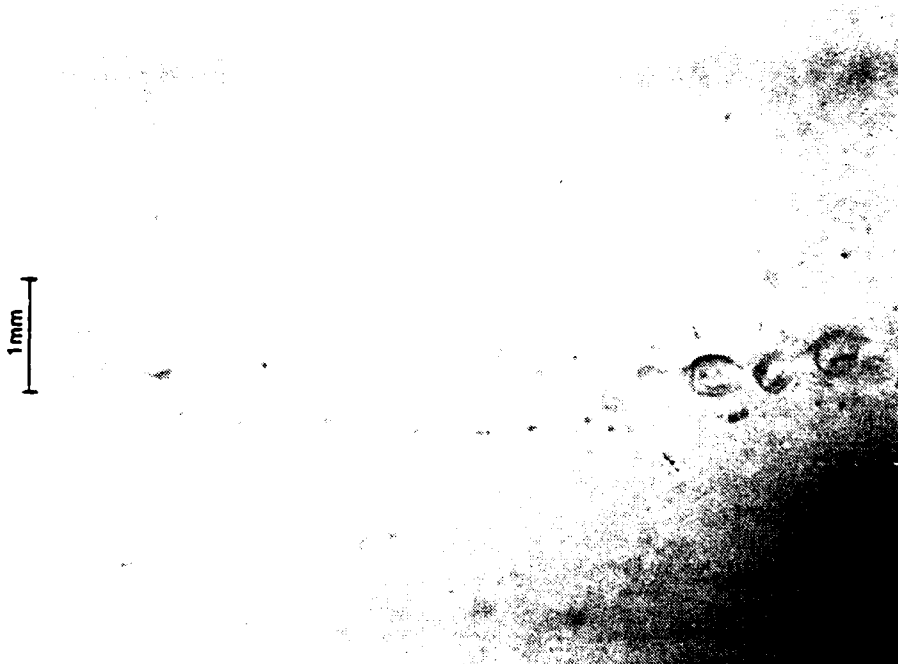
Figure 4. Corresponding 'gray spots' on the exterior and coating defects on the interior of tray (T476).

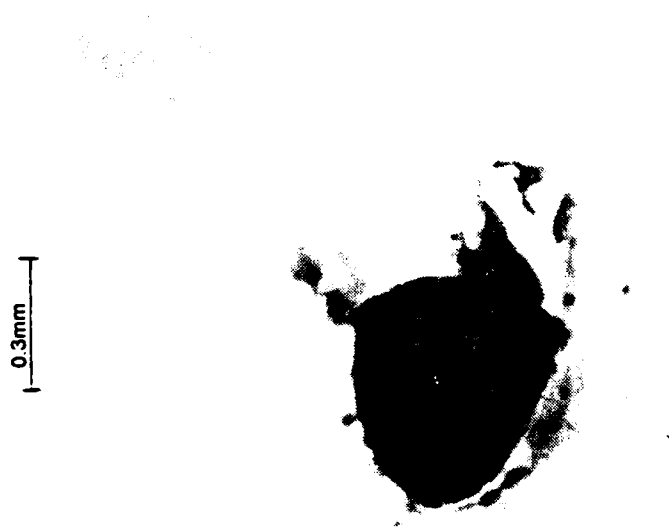
Figure 5. A half-thru pit normal appearance w/o defect on the exterior and a pit observed at the opposing position on the interior of the tray (T144).

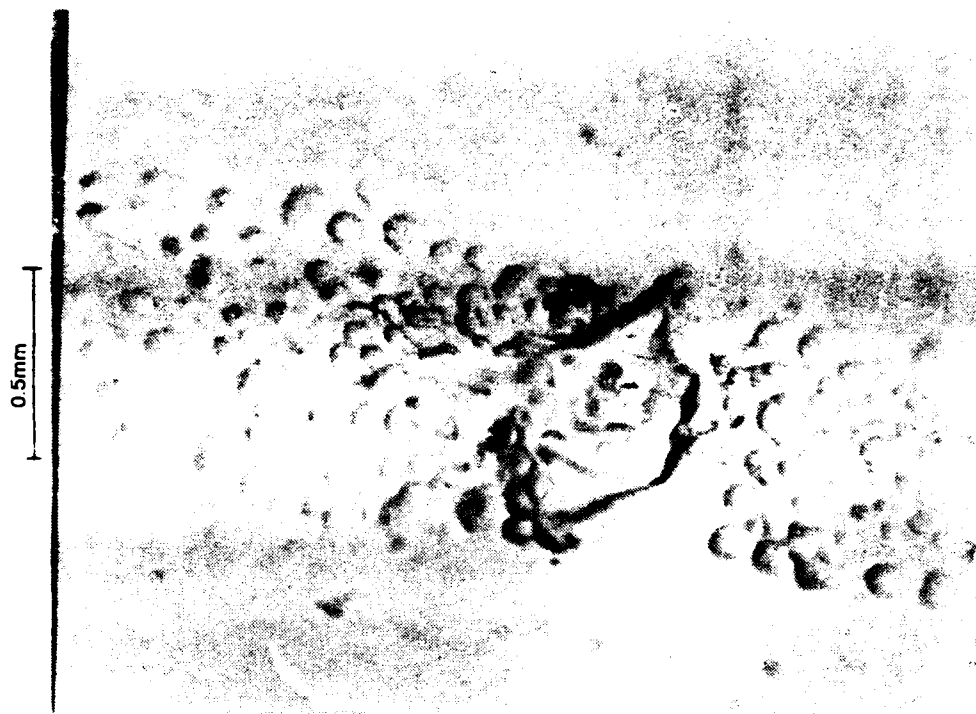
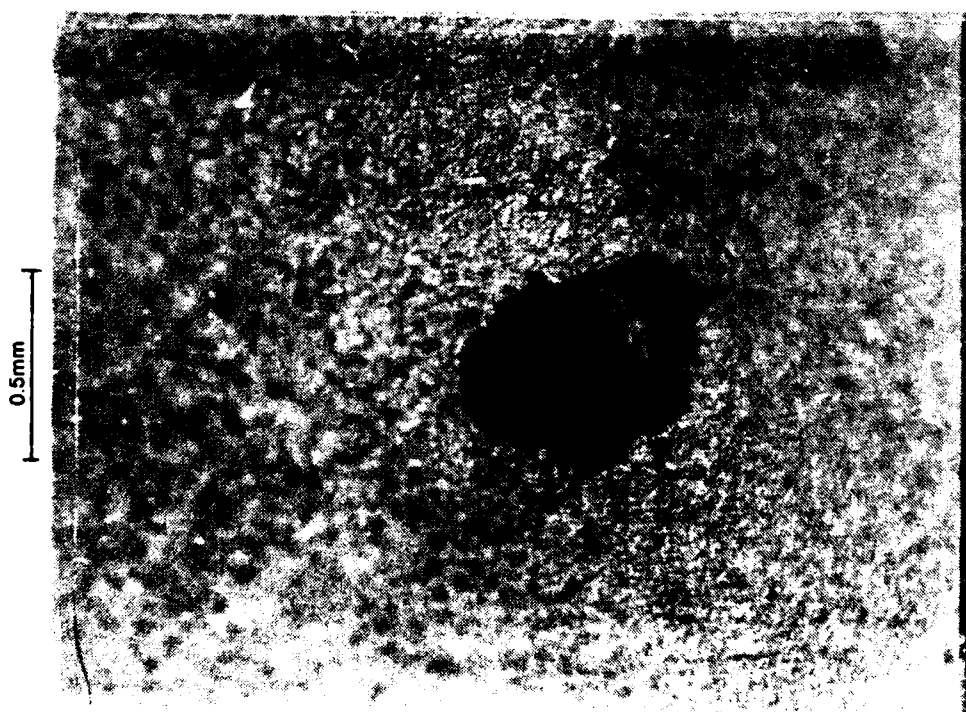
Figure 6. Blisters and pits on the interior surface corresponding to the 'gray spots' on the exterior side of the tray.

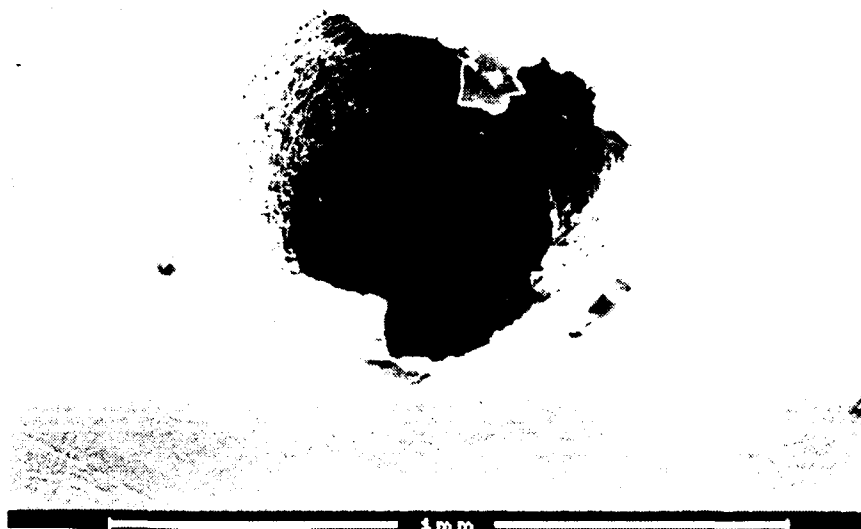
Figure 8. A thru-hole pit on the interior of a tray after ultrasonic cleaning (T134).

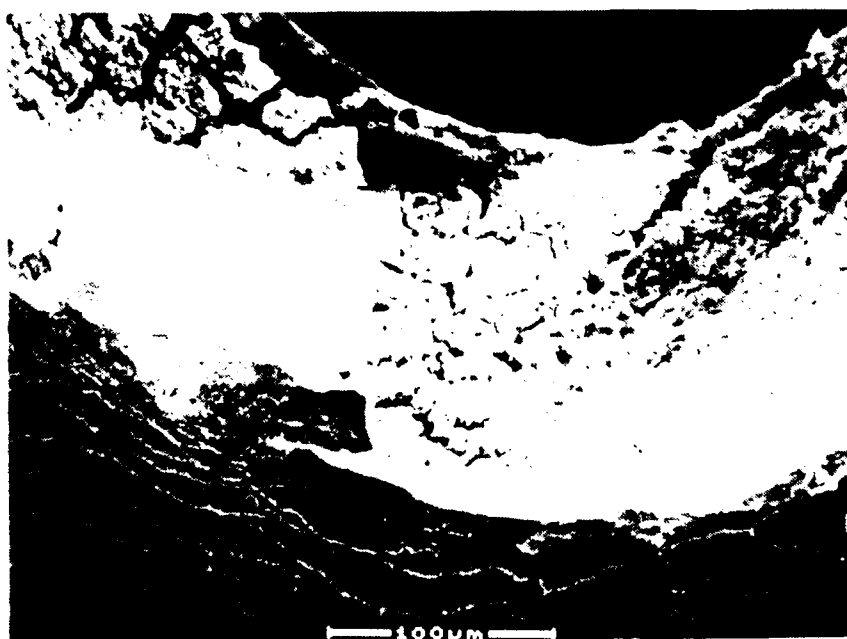
Figure 9. Detailed view of a pit wall after ultrasonic cleaning (T134).

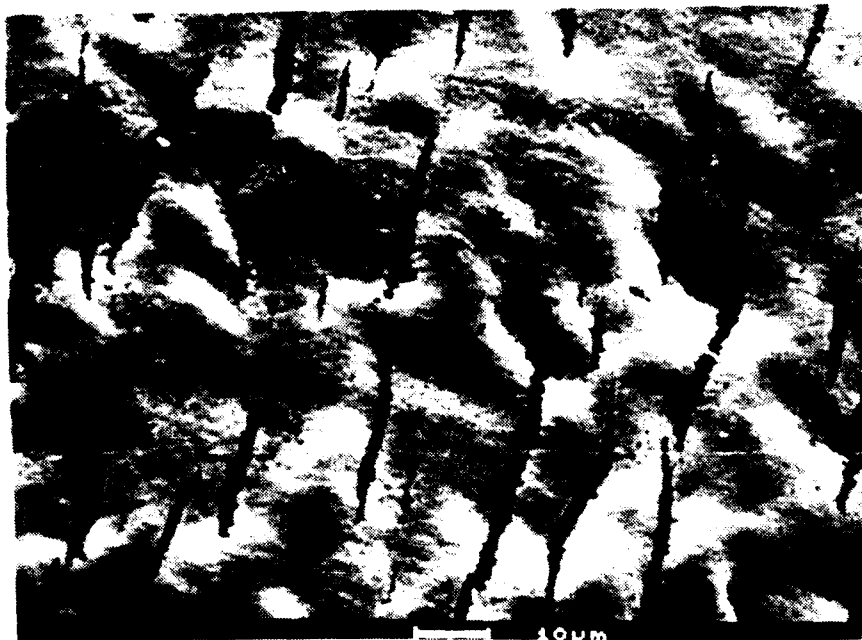
It should be noted that since the white vinyl coating is relatively soft, it is susceptible to mechanical damage and is then permeable to water. The epoxy coating beneath the vinyl is hard and brittle and contains internal stresses generated during the curing cycle. Also, the coatings are applied to the tin-free steel sheet prior to stamping into the desired tray pack form. Because of the nature of the epoxy, it is likely that the stamping operation will cause cracks to form in the epoxy coating particularly in areas of high stress. These cracks could be concealed by the soft ductile vinyl overlay.

In order to confirm the above, the epoxy layer was examined by SEM after the vinyl overlay was removed chemically with acetone and methyl ethyl ketone. Figure 10 shows that many small cracks 10 to 15  $\mu\text{m}$  long are present in the epoxy coating. These cracks are located in highly stressed areas (corners, edges, and sidewalls) and are aligned in a preferred orientation corresponding to a circumferential direction.

Figure 10. Microcracks in the epoxy layer at the stressed area in the interior of a virgin tray after vinyl topcoat removal.
